CHANNEL RESTORATION IN AN URBAN SALMONID STREAM

ABSTRACT

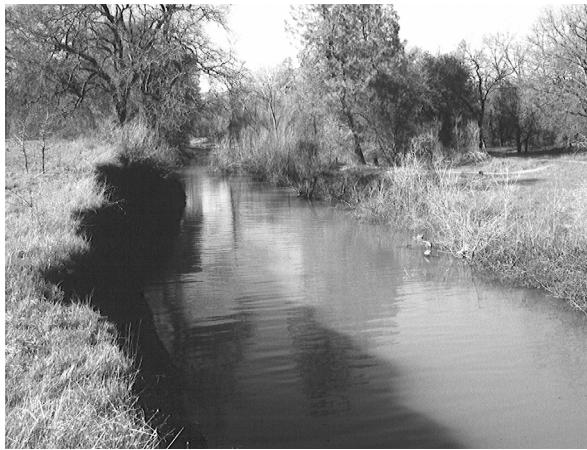
Figure 1. The high vertical bank and backwater effect.

Over the ensuing years conditions were apparently favorable for the establishment of willow, wild grape, non-native blackberry, and other vegetation on the sand bar. The vegetation, with their strong root systems, reinforced the median bar and made it resistant to erosion. During subsequent years, high, flashy discharges within Sulphur Creek (possibly influenced by urbanization) coincided with relatively low flows within the Sacramento River. During these periods, Sulphur Creek had sufficient stream energy to downcut and incise the median bar. However, with the vegetation strongly reinforcing the sand bar, the stream energy was focused onto the right bank (if looking downstream), resulting in the erosion which formed the high vertical bank along this area of Sulphur Creek.

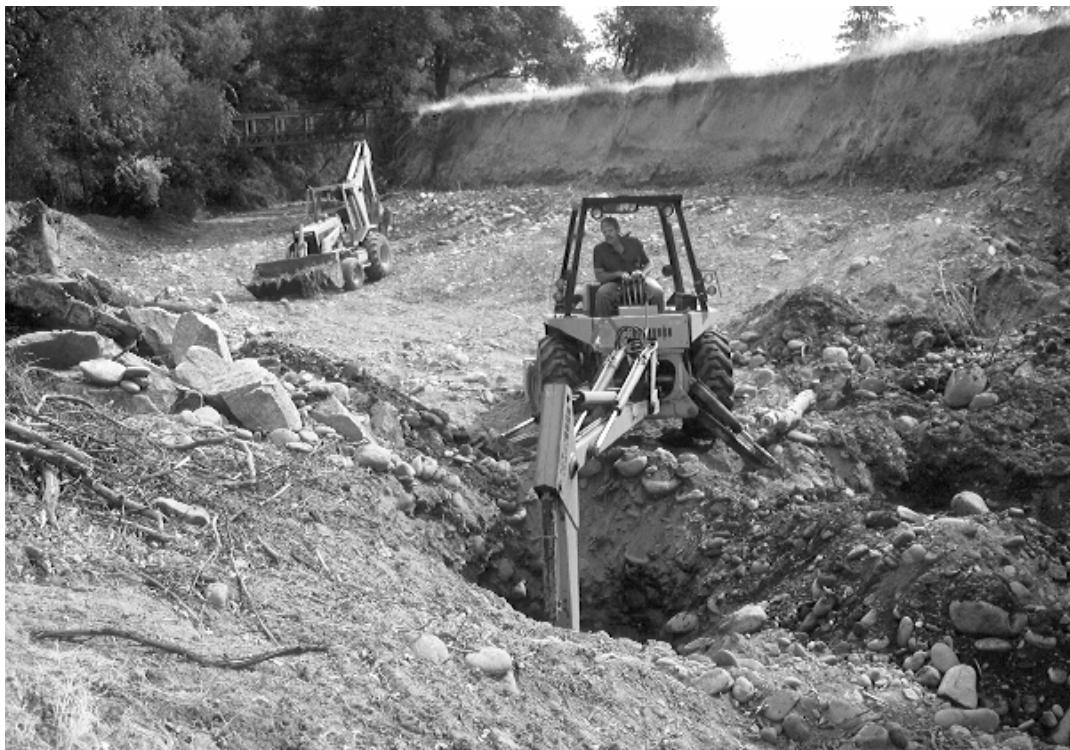
Figure 3. During the channel construction, holes were dug deep in the channel in order to plant the live poles into the vadose zone.

The backhoe was used to dig large holes over 2 m (6 ft) deep in the channel until the water table was reached. Large diameter willow and *Populus* spp. (cottonwood) poles (which were salvaged on site) were placed in these holes. This biotechnical revegetation technique, called “pole planting”, ensures that the basal ends of the live poles receive good contact with the vadose zone and water table in the soil, so irrigation is not required in the dry summer months. This technique was also combined with rootwad revetments, which direct high-energy flows away from the new banks, and also create scour pools and fish habitat. A total of six rootwads were installed for this project. The rootwads were obtained from a subdivision development, and the trunks were not long enough to key into the banks. The short trunks (boles) were anchored using only rocks and live pole cuttings.

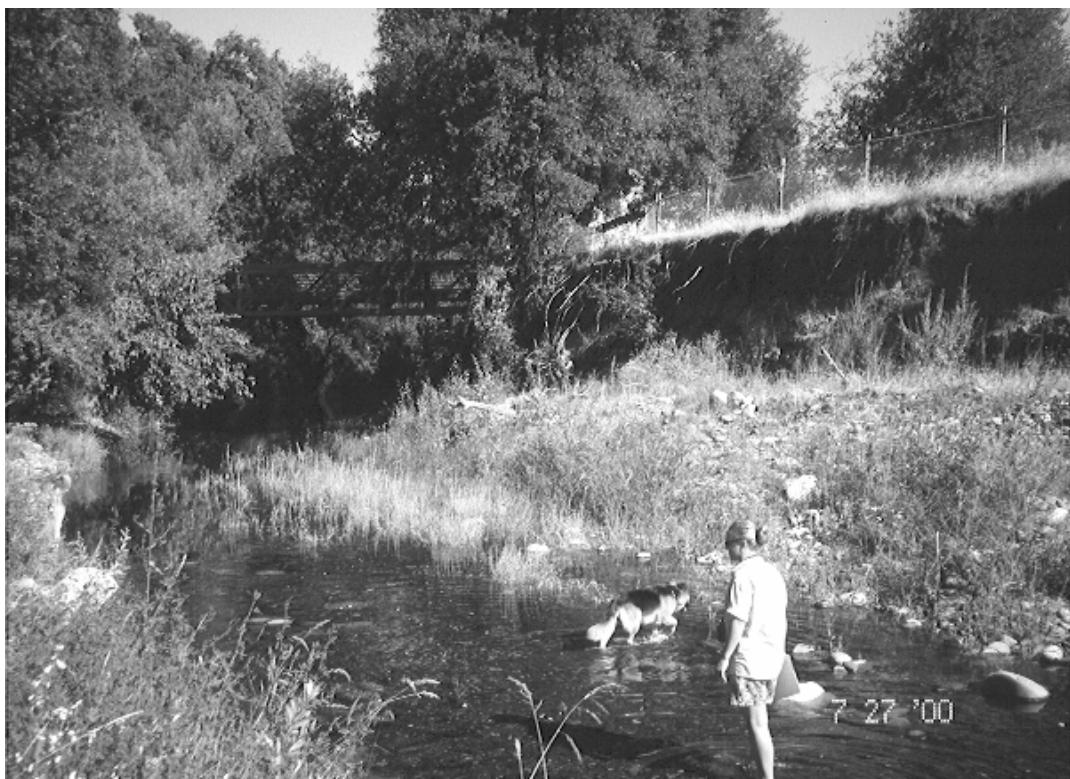
Figure 4. After - almost a year later, the banks are revegetating well.

Contrary to expectations, willow container plants did not have a higher survival rate than willow stakes, although all seemed to survive better in shaded areas rather than hot, exposed areas. The deeply planted live pole cuttings and brushlayers were very successful, with a 90% success rate. These were planted deeply into the vadose zone. It

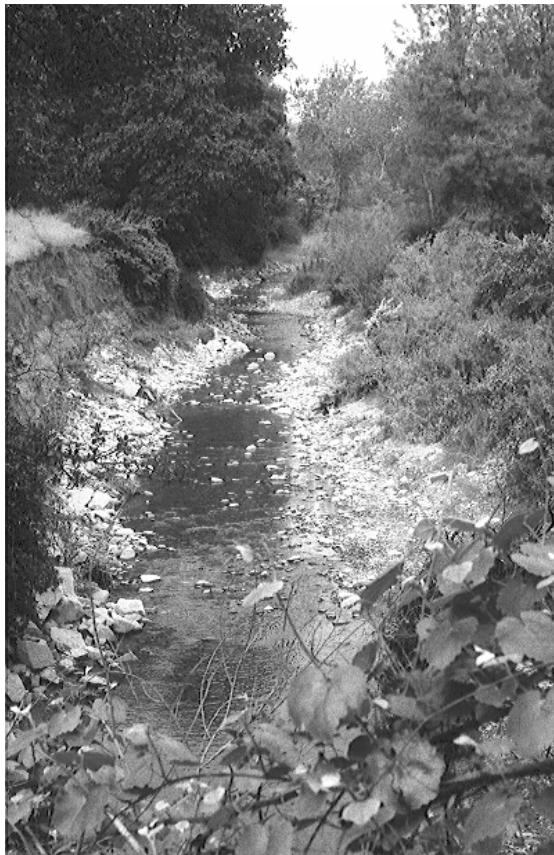
Figure 7 and 8. Before and After. The left photo shows the channel before reconstruction. The right photo shows the channel shortly after project completion, with volunteers planting riparian vegetation.

After the initial seeding of native grass species for erosion control, SWAG and the Arboretum sponsored several community-oriented “planting days”. On one of these “planting days” over 80 community members volunteered. These volunteer crews planted native grass plugs and native riparian and upland species that were donated from the Arboretum and local agencies.

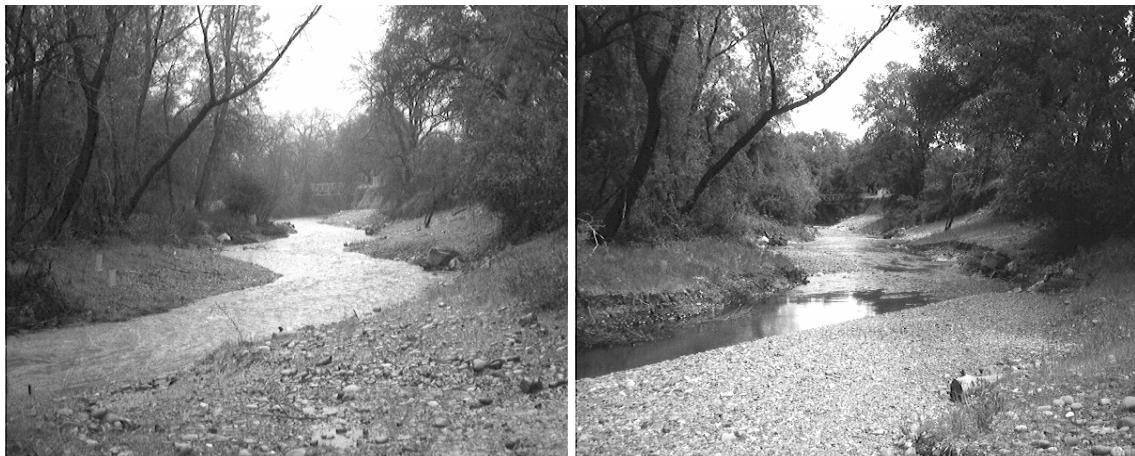
Figure 9 and 10. It is sometimes difficult to envision the dynamic changes that will occur after channel restoration in a seasonal stream, such as the formation of point bars. It is interesting to realize that while the gravels composing the point bars will move through the system, the point bars will still remain. These two photos show the changes that occurred in the new channel after the first large storm event.

The removal of the excess sediment within the streambed resulted in channel adjustment approximately 200 m upstream from the restoration reach. The stream “head cut” through previously embedded bed materials, and this change in the channel led to the formation of gravel bars. The composition of the bars is desirable spawning material. Because the aggraded streambed was lowered during restoration, the backwater from the Sacramento River remains in the lowest portion of the project reach for a longer period during the dry summers, and this also aids in the escapement of salmon juveniles. Streamside vegetation is quickly establishing now that more water is available during the summers.
